It has come to our attention, under certain circumstances, the model TW18HQ2A3D-I will experience excessive ice buildup on the indoor coil. This typically occurs under the following conditions:

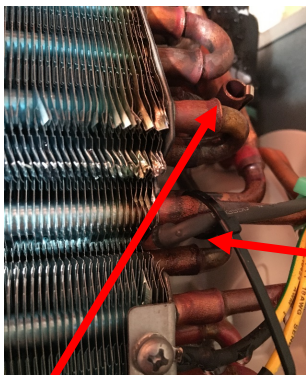
Factory Sensor Mount

New Sensor Location

- Power down unit at breaker
- Remove front case from indoor unit
- Locate factory coil sensor mounting location
- Pull sensor straight out of mount
- Relocate sensor to location shown in picture, ensuring a snug fit between the sensor, coil, and u-bend. Zip-tie in place.

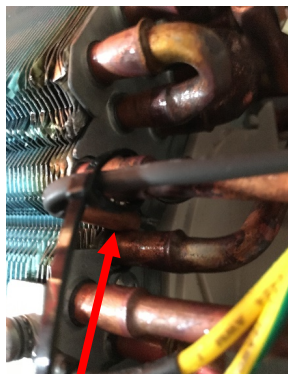
New Sensor Location
